**Flood Control Project Maintenance
Levee Inspections**
LMA District Cover Sheet
Spring 2014 Levee Inspection Results

San Joaquin County Flood Control and Water Conservation District

Spring 2014 Levee Inspection Results

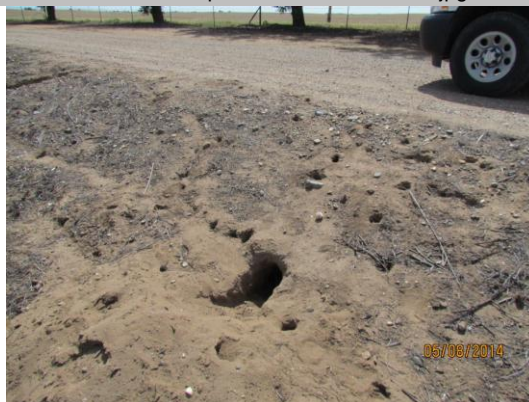
Photo 1 of 1 : pkazi_s_20140512_977.jpg

Rodent holes were found on the waterside of the levee.

LM Start	2.68	Rating **	M	Issue No.	176
LM End	2.68	Issue Type +	Ma	Location *	WS
Category	Earthen Levee			GPS Latitude/Longitude	
				Start	End
Item	Animal Control			38.029061 °	38.029061 °
				-121.048870 °	-121.048870 °
DWR ID	DWR_NA0017_16_s _ 2014_176				
Action/Comments					
No rodents visible, but rodent burrows visible; need to backfill and compact or grout burrows.

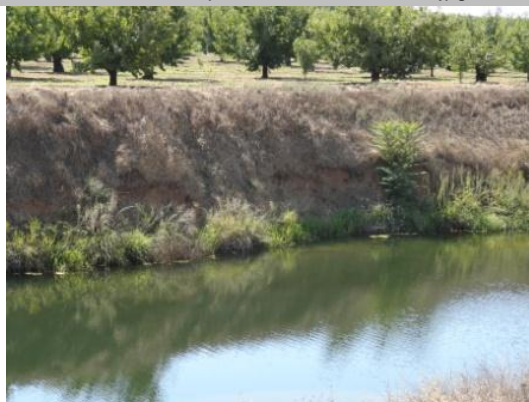
Photo 1 of 1 : pkazi_s_20140415_596.jpg

LM Start	3.00	Rating **	U	Issue No.	177
LM End	3.06	Issue Type +	Ma	Location *	WS
Category	Supplemental			GPS Latitude/Longitude	
				Start	End
Item	DWR Erosion Survey			38.026670 °	38.026670 °
				-121.053031 °	-121.053031 °
DWR ID	DWR_NA0017_16_s_2014_177				
Action/Comments					
Inspector Comments: 9/12/2013: No significant changes observed. 08/22/2012: Site Comprised of series of pocket and scarp erosions. Some of erosions are covered by grass or shrubs. There is no levee structure on site. The levee crest width and levee height were not measured or estimated in the field. [2013 Site ID:NA0017U16RM20]

Front view of erosion.

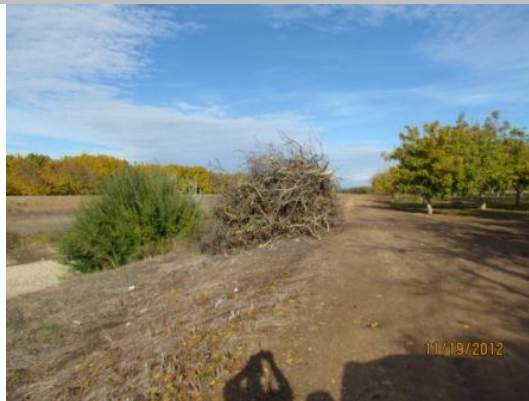
Photo 1 of 1 : pkazi_s_20140415_498.jpg

LM Start	3.35	Rating **	M	Issue No.	52
LM End	3.35	Issue Type +	En	Location *	WS
Category	Earthen Levee			GPS Latitude/Longitude	
				Start	End
Item	Encroachments			38.023257 °	38.023257 °
				-121.058158 °	-121.058158 °
DWR ID	DWR_NA0017_16_s _ 2012_52				
Action/Comments					
Prunings					
Inspector Comments: Burn pile has been burned but new material has been placed.

Prunings were found on the waterside shoulder of the levee looking upstream.

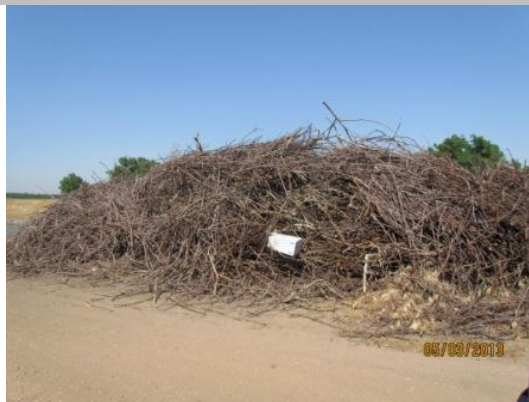
Photo 1 of 1 : pkazi_s_20140415_499.jpg

LM Start	3.52	Rating **	M	Issue No.	53
LM End	3.52	Issue Type +	Ma	Location *	WS
Category	Earthen Levee			GPS Latitude/Longitude	
				Start	End
Item	Encroachments			38.021650 °	38.021650 °
				-121.060312 °	-121.060312 °
DWR ID	DWR_NA0017_16_s _ 2012_53				
Action/Comments					
Prunings					
Inspector Comments: Burn pile has been burned but new material has been placed.

Prunings were found on the waterside shoulder of the levee looking downstream.

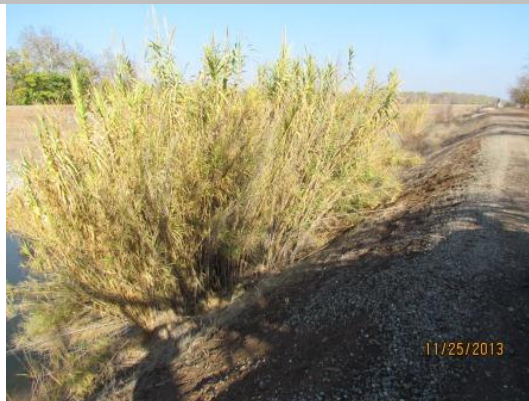
Photo 1 of 1 : pkazi_s_20140415_572.jpg

Arundo was found on the waterside toe of the levee looking upstream.

LM Start	3.59	Rating **	M	Issue No.	152
LM End	3.59	Issue Type +	Ma	Location *	WS
Category	Earthen Levee			GPS Latitude/Longitude	
				Start	End
Item	Vegetation			38.020965 °	38.020965 °
				-121.061215 °	-121.061215 °
DWR ID	DWR_NA0017_16_f_2013_152				
Action/Comments					
Remove the wild growth other than native grasses from the levee slopes.

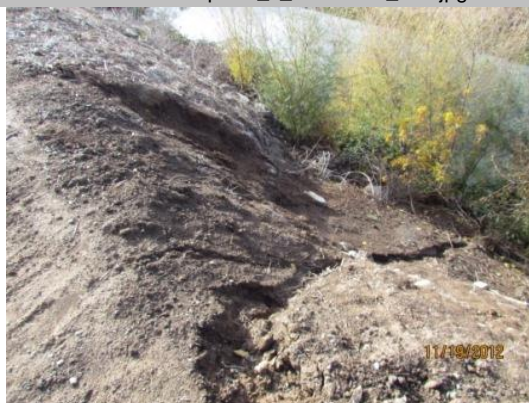
Photo 1 of 2 : pkazi_s_20140415_626.jpg

Slope instability was found on the waterside slope of the levee looking downstream.

LM Start	3.65	Rating **	M	Issue No.	230
LM End	3.65	Issue Type +	Ma	Location *	WS
Category	Earthen Levee			GPS Latitude/Longitude	
				Start	End
Item	Erosion / Bank Caving			38.020433 °	38.020433 °
				-121.061867 °	-121.061867 °
DWR ID	DWR_NA0017_16_f_2012_230				
Action/Comments					
Schedule repair of erosion site prior to the next inspection.

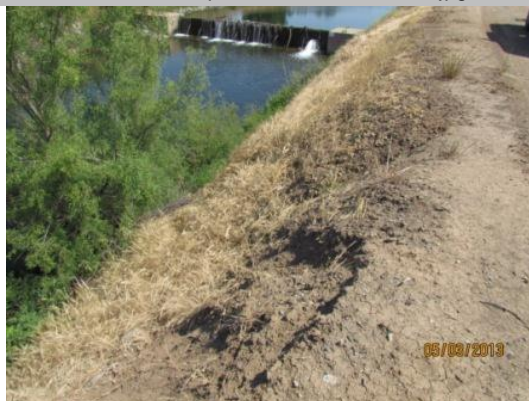
Photo 2 of 2 : pkazi_s_20140415_627.jpg

Erosion was found on the waterside slope of the levee looking upstream.

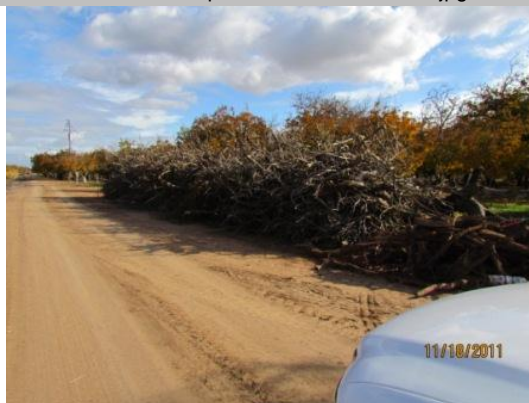
Photo 1 of 1 : pkazi_s_20140415_609.jpg

LM Start	3.66	Rating **	M	Issue No.	206
LM End	3.66	Issue Type +	En	Location *	LS
Category	Earthen Levee			GPS Latitude/Longitude	
				Start	End
Item	Encroachments			38.020351 °	38.020351 °
				-121.061944 °	-121.061944 °
DWR ID	DWR_NA0017_16_s_2012_206				
Action/Comments					
Prunings

Prunings were found on the landside of the levee looking upstream.

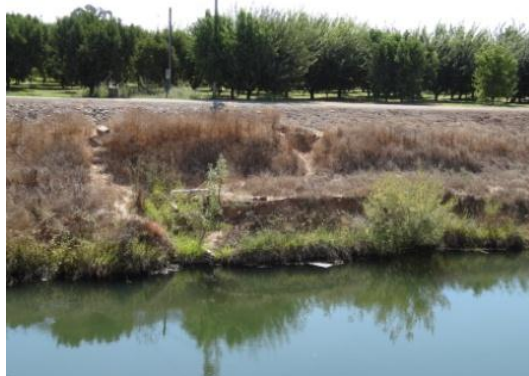
Photo 1 of 1 : pkazi_s_20140415_605.jpg

LM Start	3.89	Rating **	M	Issue No.	201
LM End	3.91	Issue Type +	Ma	Location *	WS
Category	Supplemental			GPS Latitude/Longitude	
				Start	End
Item	DWR Erosion Survey			38.018100 °	38.018100 °
				-121.065170 °	-121.065170 °
DWR ID	DWR_NA0017_16_s _ 2014_201				
Action/Comments					
Inspector Comments: 9/12/2013: No significant changes observed. 08/22/2012: River-induced erosion occurred on the berm, while the runoff-induced erosion occurred on the levee slope. Site is covered with vegetation. There is no levee structure on site. The levee crest width and levee height were not measured or estimated in the field. [2013 Site ID:NA0017U16RM19.18]

Closer view at the erosion.

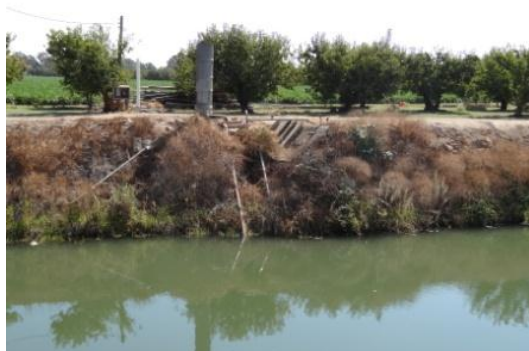
Photo 1 of 1 : pkazi_s_20140415_608.jpg

LM Start	4.32	Rating **	U	Issue No.	205
LM End	4.34	Issue Type +	Ma	Location *	WS
Category	Supplemental			GPS Latitude/Longitude	
				Start	End
Item	DWR Erosion Survey			38.012792 °	38.012792 °
				-121.068073 °	-121.068073 °
DWR ID	DWR_NA0017_16_s _ 2014_205				
Action/Comments					
Inspector Comments: 9/12/2013: No significant changes observed. 08/22/2012: An irrigation pipe is present at the site, but probably did not cause the erosion. There is no levee structure on site. The levee crest width and levee height were not measured or estimated in the field. [2013 Site ID:NA0017U16RM18.69]

Front view of erosion.

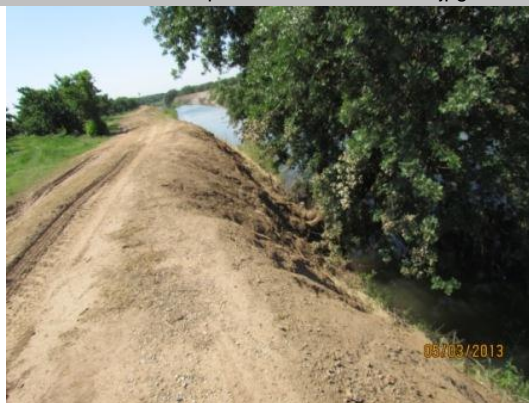
Photo 1 of 1 : pkazi_s_20140415_625.jpg

Slope instability was found on the waterside shoulder of the levee looking downstream.

LM Start	4.34	Rating **	M	Issue No.	228
LM End	4.34	Issue Type +	Ma	Location *	WS
Category	Earthen Levee			GPS Latitude/Longitude	
				Start	End
Item	Slope Stability			38.012288 °	38.012288 °
				-121.068239 °	-121.068239 °
DWR ID	DWR_NA0017_16_f_2012_228				
Action/Comments					
Repair slope instability.

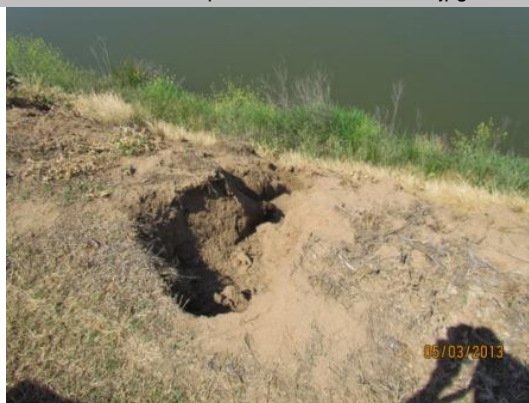
Photo 1 of 2 : pkazi_s_20140415_515.jpg

Erosion was found on the waterside shoulder of the levee looking downstream.

LM Start	4.43	Rating **	M	Issue No.	73
LM End	4.43	Issue Type +	Ma	Location *	WS
Category	Earthen Levee			GPS Latitude/Longitude	
				Start	End
Item	Erosion / Bank Caving			38.011053 °	38.011053 °
				-121.068651 °	-121.068651 °
DWR ID	DWR_NA0017_16_s_2013_73				
Action/Comments					
Schedule repair of erosion site prior to the next inspection.

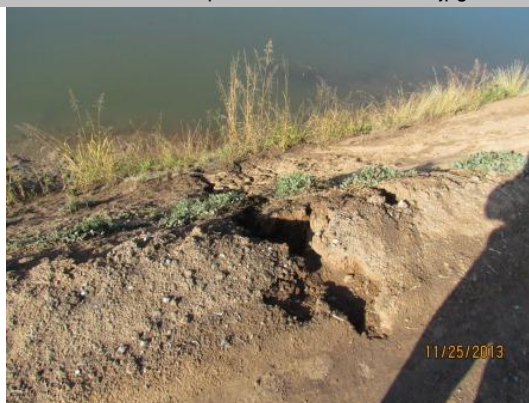
Photo 2 of 2 : pkazi_s_20140415_516.jpg

Updated picture of the erosion on the waterside of the levee looking upstream.

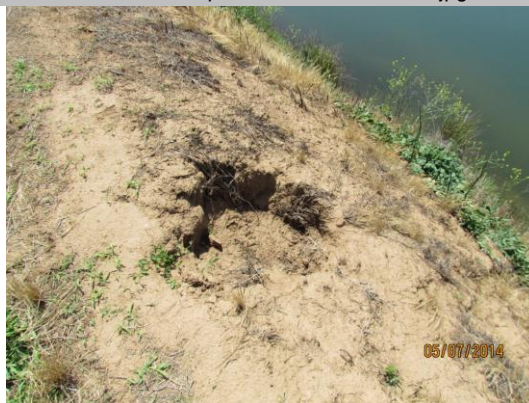
Photo 1 of 1 : pkazi_s_20140512_976.jpg

A slope instability was found on the waterside of the levee looking downstream.

LM Start	4.52	Rating **	M	Issue No.	141
LM End	4.52	Issue Type +	Ma	Location *	WS
Category	Earthen Levee			GPS Latitude/Longitude	
				Start	End
Item	Slope Stability			38.009858 °	38.009858 °
				-121.069005 °	-121.069005 °
DWR ID	DWR_NA0017_16_s_2014_141				
Action/Comments					
Repair slope instability.

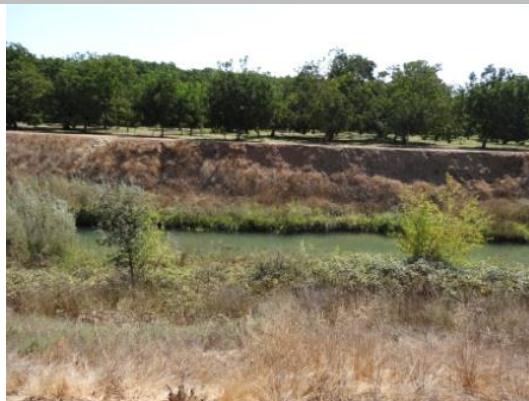
Photo 1 of 1 : pkazi_s_20140415_610.jpg

LM Start	5.03	Rating **	U	Issue No.	207
LM End	5.03	Issue Type +	Ma	Location *	WS
Category	Supplemental			GPS Latitude/Longitude	
				Start	End
Item	DWR Erosion Survey			38.003730 °	38.003730 °
				-121.073080 °	-121.073080 °
DWR ID	DWR_NA0017_16_s_2014_207				
Action/Comments					
Inspector Comments: 9/12/2013: Site has been surveyed and the pocket erosion has developed toward levee crest. 08/22/2012: A pocket erosion at the levee toe and on lower slope. The levee surface at the upper slope also shows signs of erosion due to poor maintenance. There is no levee structure on site. The levee crest width and levee height were not measured or estimated in the field. [2013 Site ID:NA0017U16RM17.99]

View from right river bank.

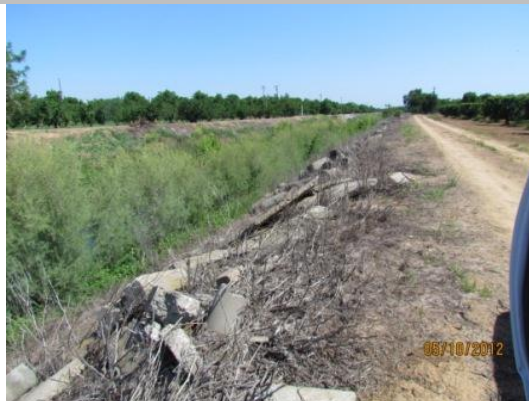
Photo 1 of 2 : pkazi_s_20140415_602.jpg

Debris was found on the waterside of the levee looking upstream.

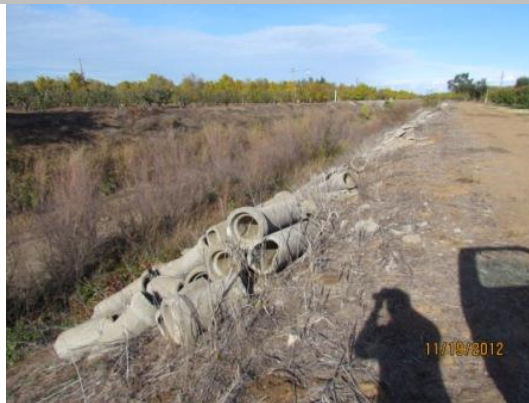
Photo 2 of 2 : pkazi_s_20140415_603.jpg

Concrete debris was found on the waterside slope of the levee looking upstream.

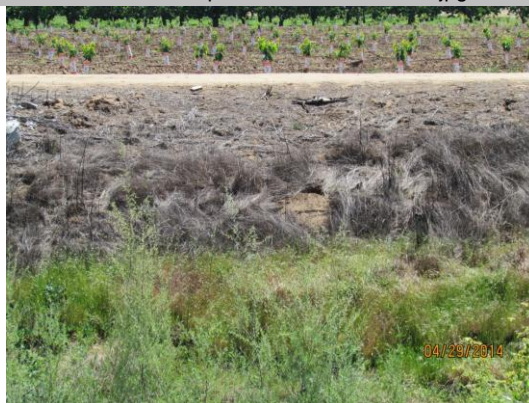
Photo 1 of 1 : pkazi_s_20140505_943.jpg

View of the animal hole on the waterside slope of the levee. The picture was taken from the opposite side of the levee.

LM Start	5.33	Rating **	M	Issue No.	42
LM End	5.33	Issue Type +	Ma	Location *	WS
Category	Earthen Levee			GPS Latitude/Longitude	
				Start	End
Item	Animal Control			38.000057 °	38.000057 °
				-121.075773 °	-121.075773 °
DWR ID	DWR_NA0017_16_s_2014_42				
Action/Comments					
No rodents visible, but rodent burrows visible; need to backfill and

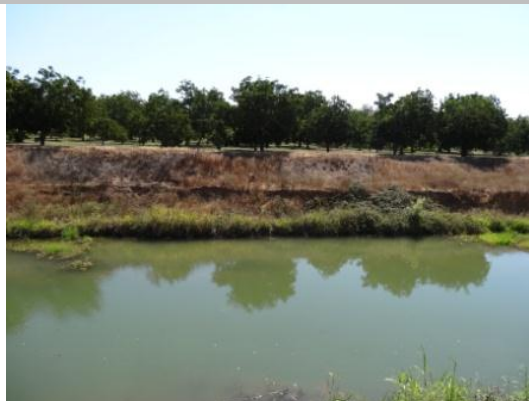
Photo 1 of 1 : pkazi_s_20140415_611.jpg

LM Start	5.52	Rating **	M	Issue No.	208
LM End	5.57	Issue Type +	Ma	Location *	WS
Category	Supplemental			GPS Latitude/Longitude	
				Start	End
Item	DWR Erosion Survey			37.997720 °	37.997720 °
				-121.077807 °	-121.077807 °
DWR ID	DWR_NA0017_16_s _ 2014_208				
Action/Comments					
Inspector Comments: 9/12/2013: No significant changes observed 08/22/2012: The site is located at the opposite river bank of E. Tobacco Road. There is no levee structure on site. The levee crest width and levee height were not measured or estimated in the field. [2013 Site ID:NA0017U16RM17.81]

Front view of the site.

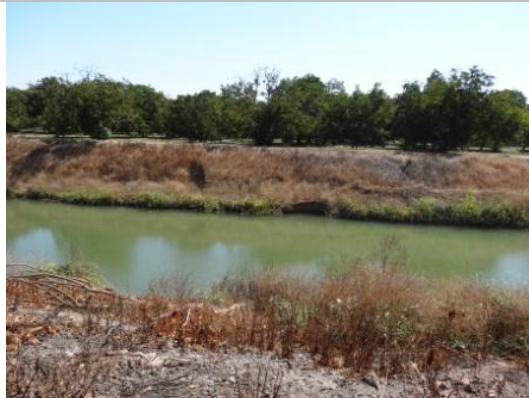
Photo 1 of 2 : pkazi_s_20140415_612.jpg

LM Start	5.55	Rating **	U	Issue No.	209
LM End	5.57	Issue Type +	Ma	Location *	WS
Category	Supplemental			GPS Latitude/Longitude	
				Start	End
Item	DWR Erosion Survey			37.995216 °	37.995216 °
				-121.080159 °	-121.080159 °
DWR ID	DWR_NA0017_16_s _ 2014_209				
Action/Comments					
Inspector Comments: 9/12/2013: The erosion seems to be caused by high river flow. Dense vegetation is present at the site. Signs of animal activities are visible. There is no levee structure on site. The levee crest width and levee height were not measured or estimated in the field. [2013 Site ID:NA0017U16RM17.27]

Looking from right river bank.

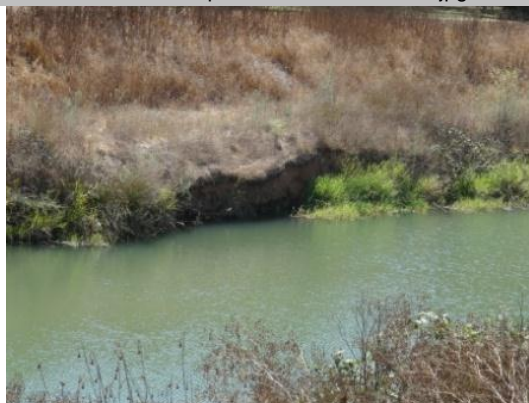
Photo 2 of 2 : pkazi_s_20140415_613.jpg

LM Start	5.55	Rating **	U	Issue No.	209 (cont)	
LM End	5.57	Issue Type +	Ma	Location *	WS	
Category	Supplemental			GPS Latitude/Longitude		
				Start		End
Item	DWR Erosion Survey			37.995216 °	37.995216 °	
				-121.080159 °	-121.080159 °	
DWR ID	DWR_NA0017_16_s _ 2014_209					
Action/Comments						
Inspector Comments: 9/12/2013: The erosion seems to be caused by high river flow. Dense vegetation is present at the site. Signs of animal activities are visible. There is no levee structure on site. The levee crest width and levee height were not measured or estimated in the field. [2013 Site ID:NA0017U16RM17.27]

Looking from right river bank.

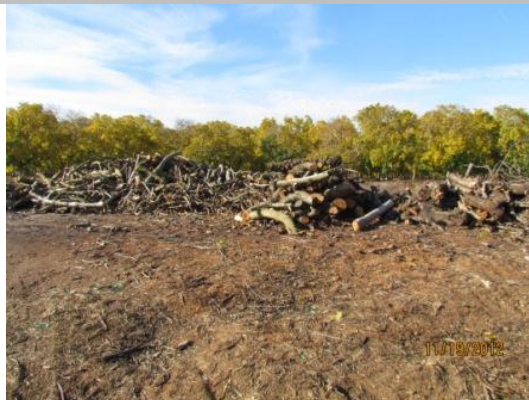
Photo 1 of 1 : pkazi_s_20140415_501.jpg

LM Start	5.83	Rating **	M	Issue No.	56
LM End	5.83	Issue Type +	En	Location *	WS
Category	Earthen Levee			GPS Latitude/Longitude	
				Start	End
Item	Encroachments			37.994268 °	37.994268 °
				-121.080850 °	-121.080850 °
DWR ID	DWR_NA0017_16_s _ 2012_56				
Action/Comments					
Prunings					
Inspector Comments: Burn pile has been burned but new material has been placed.

Prunings were found on the waterside shoulder of the levee looking upstream.

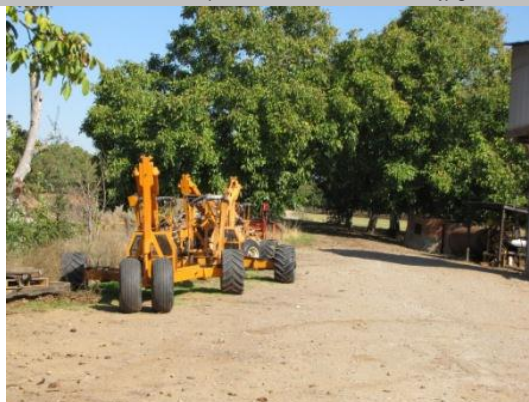
Photo 1 of 1 : pkazi_s_20140415_592.jpg

View of equipment located on the waterward side looking upstream.

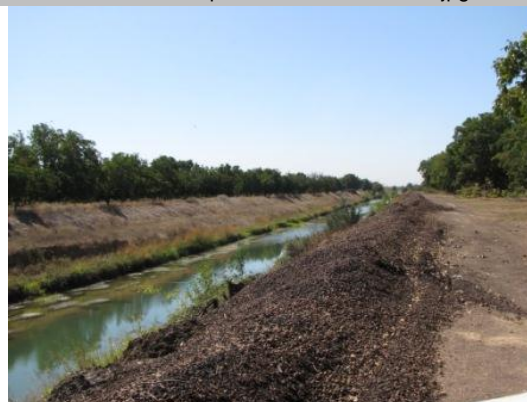
Photo 1 of 3 : pkazi_s_20140415_502.jpg

View of a large prunings pile on waterward side and access road blocking visibility and access looking upstream.

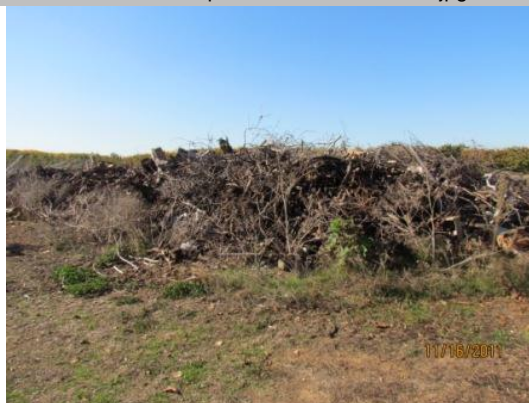
Photo 2 of 3 : pkazi_s_20140415_503.jpg

Prunings were found on the waterside of the levee looking upstream.
This picture was taken during fall 2011 inspection.

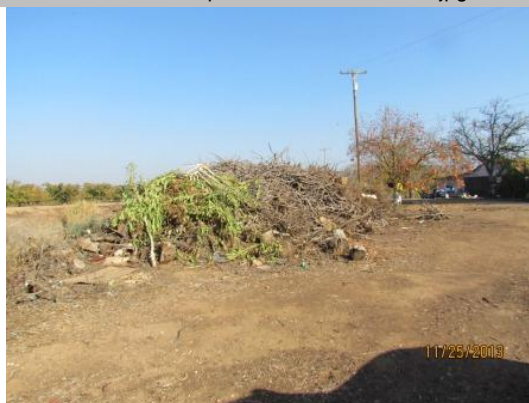
Photo 3 of 3 : pkazi_s_20140415_504.jpg

View of the prunings pile on the waterside shoulder of the levee looking upstream during fall 2013 inspection.

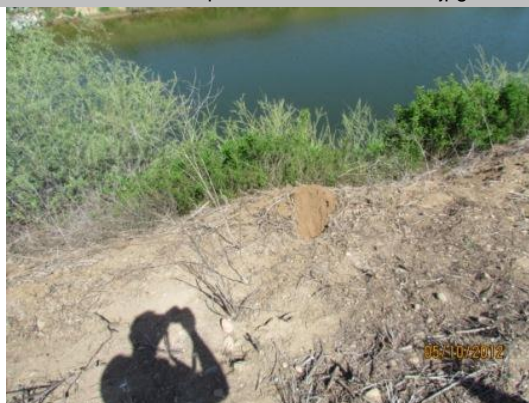
Photo 1 of 1 : pkazi_s_20140415_590.jpg

An animal hole was found on the waterside of the levee looking upstream.

LM Start	6.35	Rating **	M	Issue No.	170
LM End	6.35	Issue Type +	Ma	Location *	WS
Category	Earthen Levee			GPS Latitude/Longitude	
				Start	End
Item	Animal Control			37.988385 °	37.988385 °
				-121.086292 °	-121.086292 °
DWR ID	DWR_NA0017_16_s _ 2012_170				
Action/Comments					
No rodents visible, but rodent burrows visible; need to backfill and

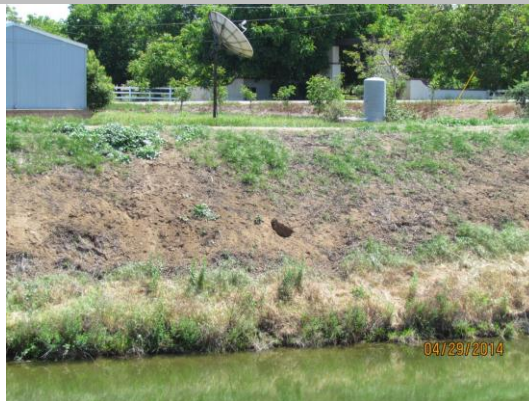
Photo 1 of 1 : pkazi_s_20140505_944.jpg

View of a rodent hole on the waterside slope of the levee. The picture was taken from the opposite side of the levee.

LM Start	6.44	Rating **	M	Issue No.	50
LM End	6.44	Issue Type +	Ma	Location *	WS
Category	Earthen Levee			GPS Latitude/Longitude	
				Start	End
Item	Animal Control			37.987303 °	37.987303 °
				-121.087292 °	-121.087292 °
DWR ID	DWR_NA0017_16_s_2014_50				
Action/Comments					
No rodents visible, but rodent burrows visible; need to backfill and compact or grout burrows.

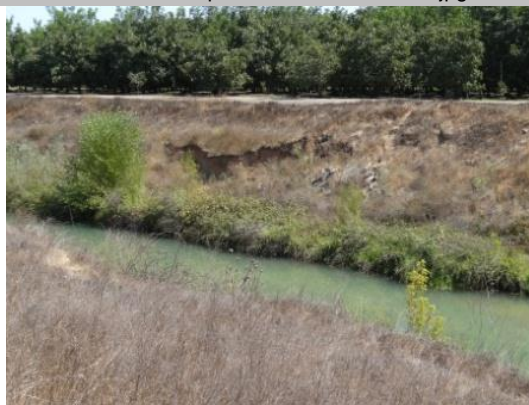
Photo 1 of 1 : pkazi_s_20140415_614.jpg

LM Start	6.72	Rating **	U	Issue No.	210
LM End	6.91	Issue Type +	Ma	Location *	WS
Category	Supplemental			GPS Latitude/Longitude	
				Start	End
Item	DWR Erosion Survey			37.983279 °	37.983279 °
				-121.090843 °	-121.090843 °
DWR ID	DWR_NA0017_16_s_2014_210				
Action/Comments					
Inspector Comments: 9/12/2013: Site has been surveyed and the erosion has worsened since last year. 08/22/2012: Discontinuous scarp or pocket erosions occurred along a long stretch of the river, with erosion height greater than 25 ft at certain points. There is no levee structure on site. The levee crest width and levee height were not measured or estimated in the field. [2013 Site ID:NA0017U16RM16.27]

Looking at the upstream end of erosion site.

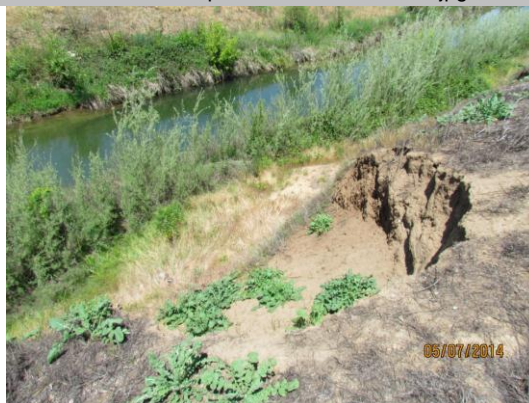
Photo 1 of 2 : pkazi_s_20140512_974.jpg

Updated picture of the erosion on the waterside slope of the levee during spring 2014 inspection.

LM Start	6.82	Rating **	M	Issue No.	151
LM End	6.82	Issue Type +	Ma	Location *	WS
Category	Earthen Levee			GPS Latitude/Longitude	
				Start	End
Item	Erosion / Bank Caving			37.982945 °	37.982945 °
				-121.091270 °	-121.091270 °
DWR ID	DWR_NA0017_16_f_2013_151				
Action/Comments					
Schedule repair of erosion site prior to the next inspection.

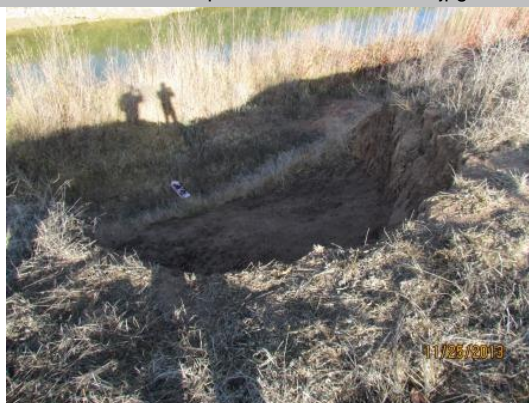
Photo 2 of 2 : pkazi_s_20140415_571.jpg

Erosion was found on the waterside slope of the levee looking upstream.

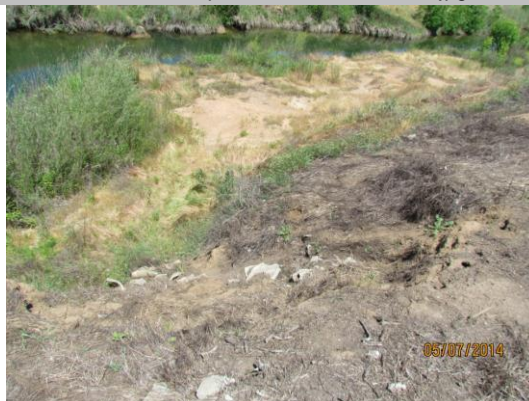
Photo 1 of 1 : pkazi_s_20140512_973.jpg

Slope instability was found on the waterside of the levee looking upstream.

LM Start	6.92	Rating **	M	Issue No.	120
LM End	6.92	Issue Type +	Ma	Location *	WS
Category	Earthen Levee			GPS Latitude/Longitude	
				Start	End
Item	Slope Stability			37.982299 °	37.982299 °
				-121.092665 °	-121.092665 °
DWR ID	DWR_NA0017_16_s_2014_120				
Action/Comments					
Repair slope instability.

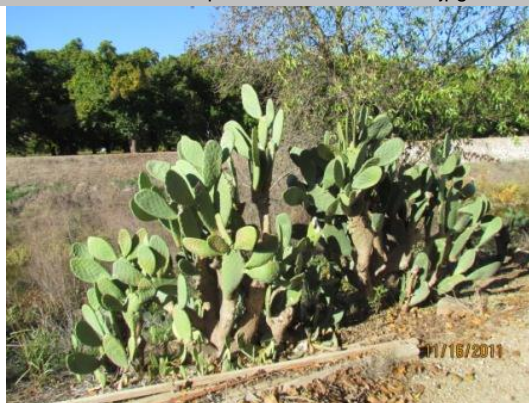
Photo 1 of 1 : pkazi_s_20140415_505.jpg

Cacti were found on the waterside of the levee looking upstream.

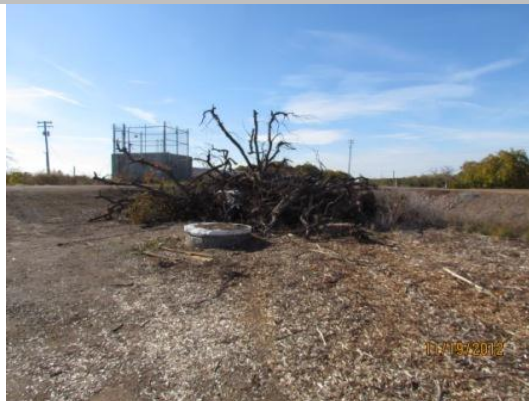
Photo 1 of 1 : pkazi_s_20140415_587.jpg

Prunings were found on the waterside shoulder of the levee looking downstream.

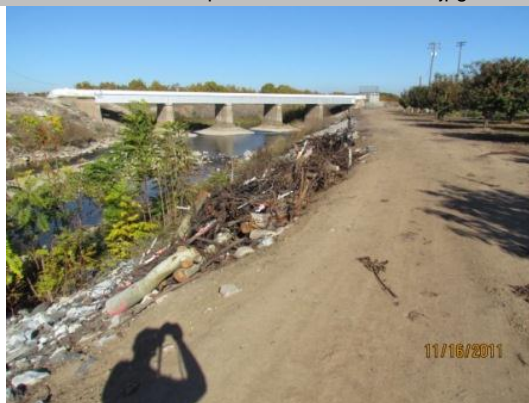
Photo 1 of 1 : pkazi_s_20140415_506.jpg

LM Start	7.37	Rating **	M	Issue No.	61
LM End	7.37	Issue Type +	Ma	Location *	WS
Category	Earthen Levee			GPS Latitude/Longitude	
				Start	End
Item	Encroachments			37.978850 °	37.978850 °
				-121.099325 °	-121.099325 °
DWR ID	DWR_NA0017_16_s_2012_61				
Action/Comments					
Debris					
Inspector Comments: Farmer has burned the material, but some new material has been placed. Farmer has been told to not put any material at this location in the future.

Debris and prunings were found on the waterside of the levee looking upstream.

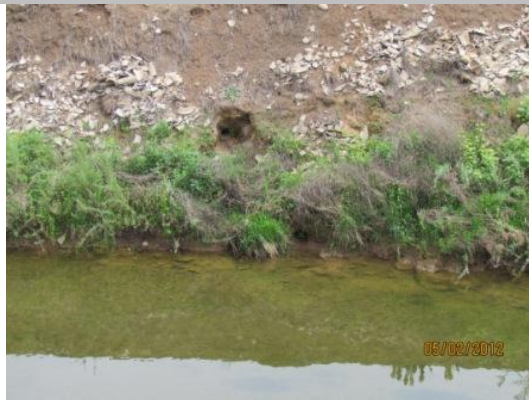
Photo 1 of 1 : pkazi_s_20140415_621.jpg

LM Start	7.57	Rating **	U	Issue No.	218
LM End	7.57	Issue Type +	Ma	Location *	WS
Category	Earthen Levee			GPS Latitude/Longitude	
				Start	End
Item	Animal Control				°
					°
DWR ID	DWR_NA0017_16_s_2012_218				
Action/Comments					
No rodents visible, but rodent burrows visible; need to backfill and compact or grout burrows.

A possible beaver den was found on waterside slope of the levee. The picture was taken from the opposite bank of the levee.

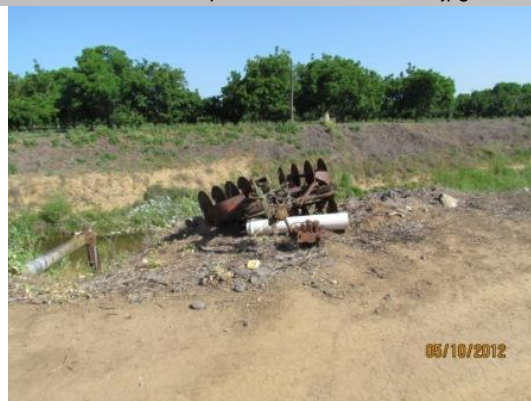
Photo 1 of 1 : pkazi_s_20140415_582.jpg

LM Start	7.68	Rating **	M	Issue No.	162
LM End	7.68	Issue Type +	En	Location *	WS
Category	Earthen Levee			GPS Latitude/Longitude	
				Start	End
Item	Encroachments			37.977000 °	37.977000 °
				-121.104234 °	-121.104234 °
DWR ID	DWR_NA0017_16_s_2012_162				
Action/Comments					
Equipment

Equipment was found on the waterside of the levee looking upstream.

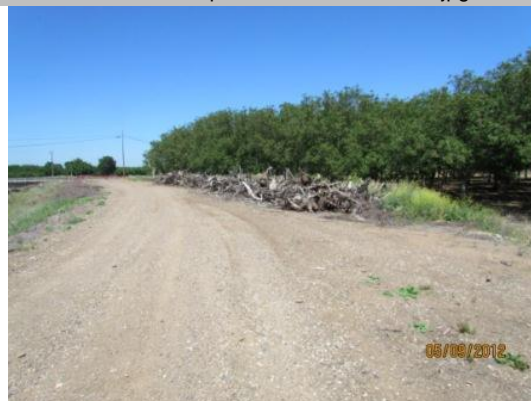
Photo 1 of 1 : pkazi_s_20140415_529.jpg

LM Start	8.34	Rating **	M	Issue No.	93
LM End	8.34	Issue Type +	En	Location *	WS
Category	Earthen Levee			GPS Latitude/Longitude	
				Start	End
Item	Encroachments			37.971311 °	37.971311 °
				-121.113033 °	-121.113033 °
DWR ID	DWR_NA0017_16_s_2012_93				
Action/Comments					
Prunings

Prunings were found on the landside of the levee looking upstream.

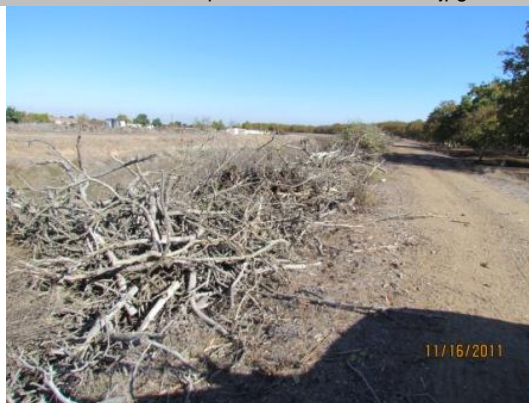
Photo 1 of 1 : pkazi_s_20140415_520.jpg

LM Start	8.54	Rating **	M	Issue No.	79
LM End	8.66	Issue Type +	Ma	Location *	WS
Category	Earthen Levee			GPS Latitude/Longitude	
				Start	End
Item	Encroachments			37.969472 °	37.969114 °
				-121.115350 °	-121.117417 °
DWR ID	DWR_NA0017_16_s_2012_79				
Action/Comments					
Prunings

Prunings were found on the waterside of the levee looking upstream.

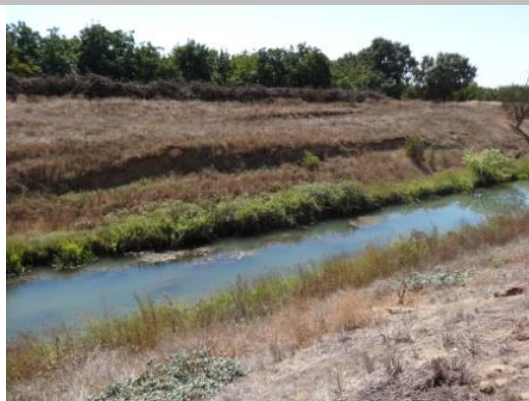
Photo 1 of 1 : pkazi_s_20140415_618.jpg

LM Start	8.61	Rating **	M	Issue No.	214
LM End	8.65	Issue Type +	Ma	Location *	WS
Category	Supplemental			GPS Latitude/Longitude	
				Start	End
Item	DWR Erosion Survey			37.969213 °	37.969213 °
				-121.116574 °	-121.116574 °
DWR ID	DWR_NA0017_16_s_2014_214				
Action/Comments					
Inspector Comments: 9/12/2013: No significant changes observed 08/22/2012: Erosion occurred on a berm of approximately 25 ft wide. Site is covered with dense vegetation. There is no levee structure on site. The levee crest width and levee height were not measured or estimated in the field. [2013 Site ID:NA0017U16RM14.48]

Looking at the site from right river bank.

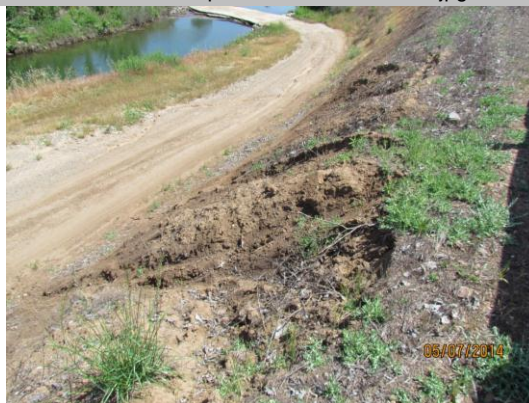
Photo 1 of 2 : pkazi_s_20140512_971.jpg

LM Start	8.85	Rating **	M	Issue No.	128
LM End	8.85	Issue Type +	Ma	Location *	WS
Category	Earthen Levee			GPS Latitude/Longitude	
				Start	End
Item	Slope Stability			37.968157 °	37.968157 °
				-121.120620 °	-121.120620 °
DWR ID	DWR_NA0017_16_s_2013_128				
Action/Comments					
Repair slope instability.

Updated picture of the slope instability on the waterside of the levee looking upstream during spring 2014 inspection.

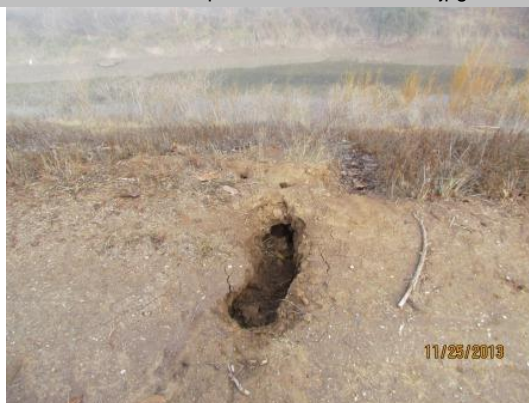
Photo 1 of 1 : pkazi_s_20140415_550.jpg

LM Start	8.94	Rating **	M	Issue No.	127
LM End	8.94	Issue Type +	Ma	Location *	WS
Category	Earthen Levee			GPS Latitude/Longitude	
				Start	End
Item	Animal Control			37.968164 °	37.968164 °
				-121.122184 °	-121.122184 °
DWR ID	DWR_NA0017_16_f_2013_127				
Action/Comments					
No rodents visible, but rodent burrows visible; need to backfill and

A collapsed animal hole was found on the waterside shoulder of the levee looking upstream.

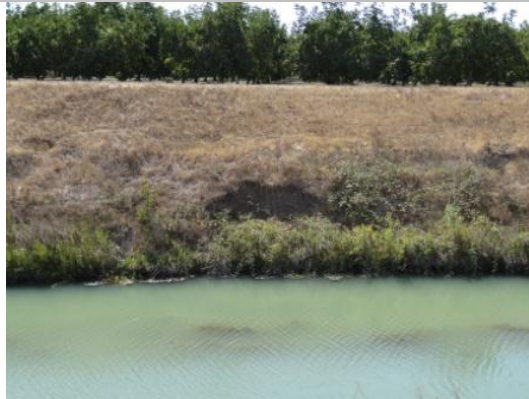
Photo 1 of 1 : pkazi_s_20140415_619.jpg

LM Start	8.99	Rating **	M	Issue No.	215
LM End	8.99	Issue Type +	Ma	Location *	WS
Category	Supplemental			GPS Latitude/Longitude	
				Start	End
Item	DWR Erosion Survey			37.966615 °	37.966615 °
				-121.127328 °	-121.127328 °
DWR ID	DWR_NA0017_16_s_2014_215				
Action/Comments					
Inspector Comments: 9/12/2013: No significant changes observed 08/22/2012: Pocket erosion at the levee toe and slope. The erosion is covered with dense vegetation. There is no levee structure on site. The levee crest width and levee height were not measured or estimated in the field. [2013 Site ID:NA0017U16RM13.86]

Front view of erosion.

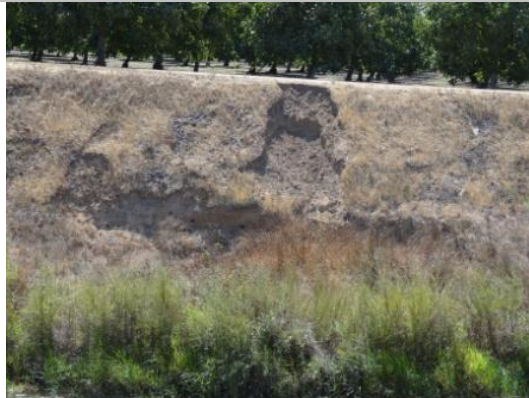
Photo 1 of 1 : pkazi_s_20140415_620.jpg

LM Start	9.07	Rating **	U	Issue No.	217
LM End	9.07	Issue Type +	Ma	Location *	WS
Category	Supplemental			GPS Latitude/Longitude	
				Start	End
Item	DWR Erosion Survey			37.967019 °	37.967019 °
				-121.127581 °	-121.127581 °
DWR ID	DWR_NA0017_16_s_2014_217				
Action/Comments					
Inspector Comments: 9/12/2013: The erosion might have been caused by river flow combined with runoff. Dense vegetation is presents at the site. There is no levee structure on site. The levee crest width and levee height were not measured or estimated in the field. [2013 Site ID:NA0017U16RM13.85]

Looking at the site from right river bank.

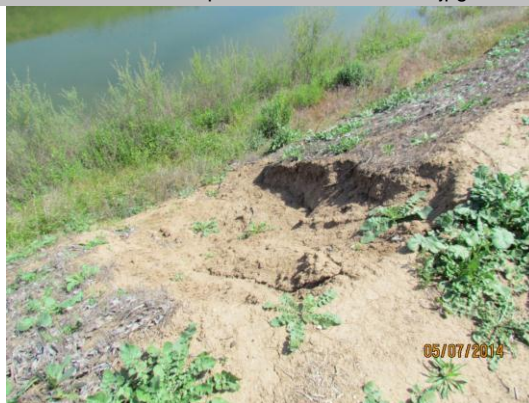
Photo 1 of 2 : pkazi_s_20140512_970.jpg

LM Start	9.27	Rating **	M	Issue No.	129
LM End	9.27	Issue Type +	Ma	Location *	WS
Category	Earthen Levee			GPS Latitude/Longitude	
				Start	End
Item	Erosion / Bank Caving			37.966580 °	37.966580 °
				-121.127376 °	-121.127376 °
DWR ID	DWR_NA0017_16_s _ 2013_129				
Action/Comments					
Schedule repair of erosion site prior to the next inspection.

Updated picture of the erosion on the waterside of the levee looking upstream during spring 2014 inspection.

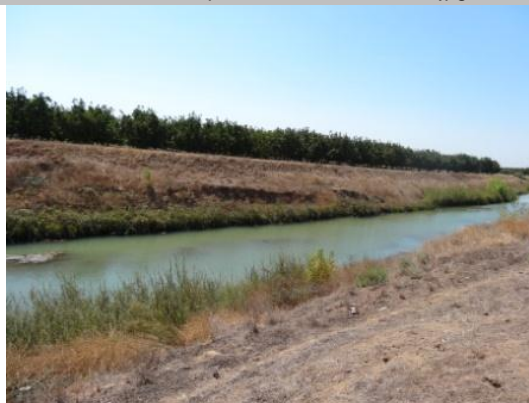
Photo 1 of 1 : pkazi_s_20140415_622.jpg

LM Start	9.39	Rating **	M	Issue No.	219
LM End	9.41	Issue Type +	Ma	Location *	WS
Category	Supplemental			GPS Latitude/Longitude	
				Start	End
Item	DWR Erosion Survey			37.966922 °	37.966922 °
				-121.129533 °	-121.129533 °
DWR ID	DWR_NA0017_16_s _ 2014_219				
Action/Comments					
Inspector Comments: 9/12/2013: No significant changes observed

Looking downstream at the erosion.

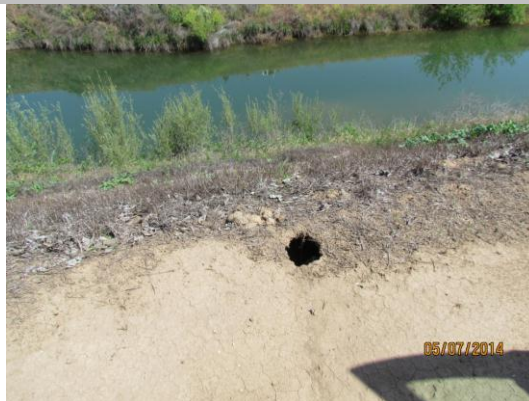
Photo 1 of 1 : pkazi_s_20140512_969.jpg

LM Start	9.44	Rating **	M	Issue No.	113
LM End	9.44	Issue Type +	Ma	Location *	WS
Category	Earthen Levee			GPS Latitude/Longitude	
				Start	End
Item	Animal Control			37.967001 °	37.967001 °
				-121.130362 °	-121.130362 °
DWR ID	DWR_NA0017_16_s_2014_113				
Action/Comments					
No rodents visible, but rodent burrows visible; need to backfill and compact or grout burrows.

An animal hole was found on the waterside shoulder of the levee looking upstream.

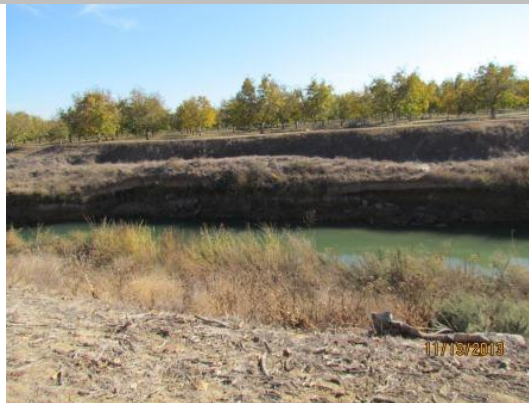
Photo 1 of 1 : pkazi_s_20140415_486.jpg

LM Start	9.45	Rating **	M	Issue No.	28
LM End	9.45	Issue Type +	Ma	Location *	WS
Category	Earthen Levee			GPS Latitude/Longitude	
				Start	End
Item	Erosion / Bank Caving			37.966239 °	37.966239 °
				-121.136172 °	-121.136172 °
DWR ID	DWR_NA0017_16_f_2013_28				
Action/Comments					
Schedule repair of erosion site prior to the next inspection. Inspector Comments: Erosion was found on the waterside toe of the levee.

View of the erosion on the waterside toe of the levee looking from the opposite side of the levee.

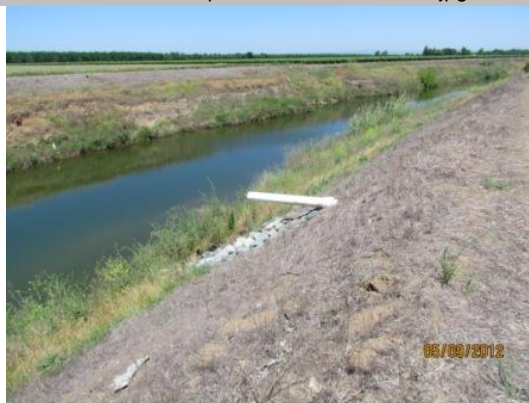
Photo 1 of 1 : pkazi_s_20140415_568.jpg

LM Start	9.50	Rating **	U	Issue No.	147
LM End	9.50	Issue Type +	En	Location *	WS
Category	Earthen Levee			GPS Latitude/Longitude	
				Start	End
Item	Encroachments			37.966952 °	37.966952 °
				-121.131360 °	-121.131360 °
DWR ID	DWR_NA0017_16_s_2012_147				
Action/Comments					
Pipe					
Inspector Comments: PVC pipe under the crown of the levee.

A PVC pipe was found on the waterside slope of the levee looking upstream.

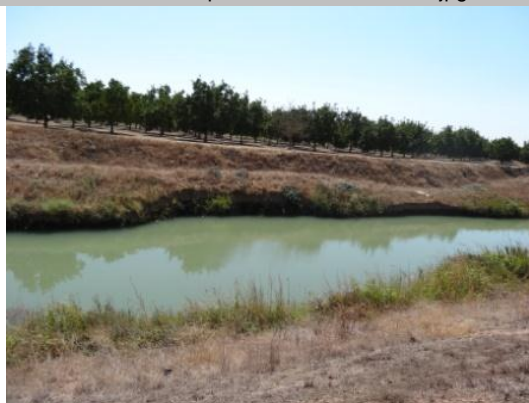
Photo 1 of 1 : pkazi_s_20140415_623.jpg

LM Start	9.58	Rating **	M	Issue No.	222
LM End	9.60	Issue Type +	Ma	Location *	WS
Category	Supplemental			GPS Latitude/Longitude	
				Start	End
Item	DWR Erosion Survey			37.967190 °	37.967190 °
				-121.133080 °	-121.133080 °
DWR ID	DWR_NA0017_16_s_2014_222				
Action/Comments					
Inspector Comments: 9/12/2013: No significant changes observed 08/22/2012: Erosion is on berm. The berm width is estimated. There is no levee structure on site. The levee crest width and levee height were not measured or estimated in the field. [2013 Site ID:NA0017U16RM13.53]

Looking downstream at the erosion.

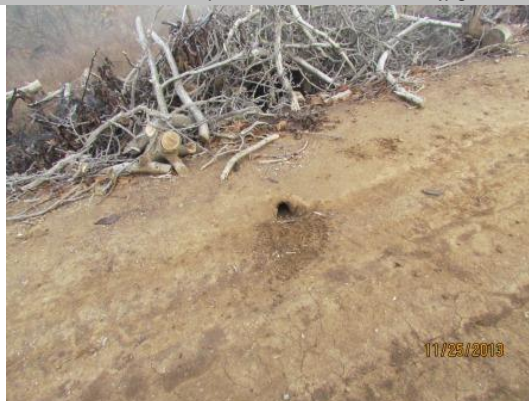
Photo 1 of 1 : pkazi_s_20140415_549.jpg

LM Start	9.64	Rating **	M	Issue No.	125
LM End	9.64	Issue Type +	Ma	Location *	WS
Category	Earthen Levee			GPS Latitude/Longitude	
				Start	End
Item	Animal Control			37.966494 °	37.966494 °
				-121.133793 °	-121.133793 °
DWR ID	DWR_NA0017_16_f_2013_125				
Action/Comments					
No rodents visible, but rodent burrows visible; need to backfill and compact or grout burrows.

A rodent hole was found on the waterside shoulder of the levee looking upstream.

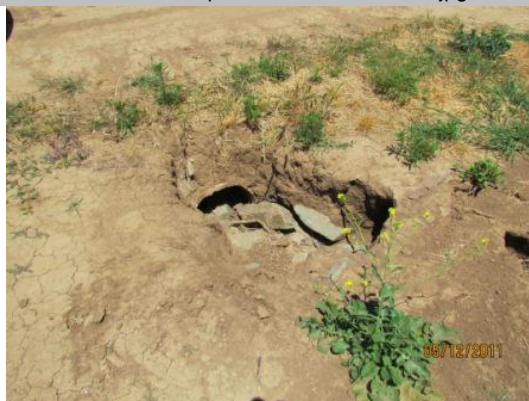
Photo 1 of 1 : pkazi_s_20140415_601.jpg

LM Start	9.77	Rating **	A/W	Issue No.	194
LM End	9.77	Issue Type +	En	Location *	LS
Category	Earthen Levee			GPS Latitude/Longitude	
				Start	End
Item	Encroachments			37.965854 °	37.965854 °
				-121.135960 °	-121.135960 °
DWR ID	DWR_NA0017_16_s_2012_194				
Action/Comments					
Pipe Inspector Comments: Drain pipe from the farmer needs repair.

An abandon pipe was left by the farmer. The picture was taken from the toe of the landside of the levee looking upstream.

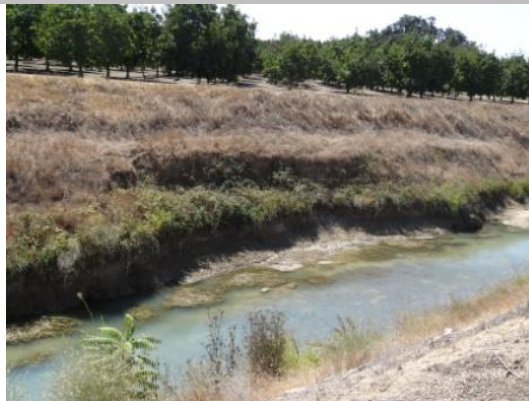
Photo 1 of 1 : pkazi_s_20140415_624.jpg

LM Start	10.16	Rating **	M	Issue No.	223
LM End	10.18	Issue Type +	Ma	Location *	WS
Category	Supplemental			GPS Latitude/Longitude	
				Start	End
Item	DWR Erosion Survey			37.964735 °	37.964735 °
				-121.142503 °	-121.142503 °
DWR ID	DWR_NA0017_16_s _ 2014_223				
Action/Comments					
Inspector Comments: 9/12/2013: No significant changes observed. 08/22/2012: Dense vegetation on site. There is no levee structure on site. The levee crest width and levee height were not measured or estimated in the field. [2013 Site ID:NA0017U16RM12.95]

Front view of erosion.

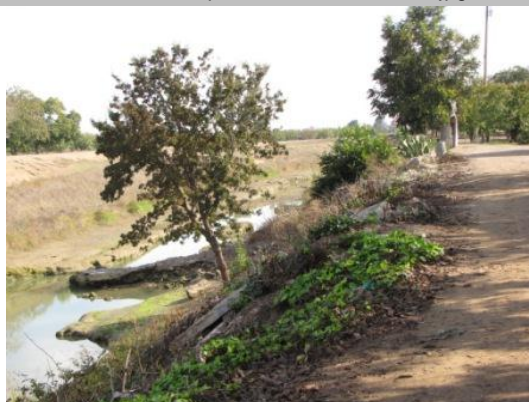
Photo 1 of 1 : pkazi_s_20140415_579.jpg

LM Start	10.84	Rating **	M	Issue No.	159
LM End	10.88	Issue Type +	En	Location *	WS
Category	Earthen Levee			GPS Latitude/Longitude	
				Start	End
Item	Vegetation			37.963704 °	37.963524 °
				-121.154321 °	-121.155045 °
DWR ID	DWR_NA0017_16_s_2012_159				
Action/Comments					
Landscaping

View of landscaping on waterward side looking upstream.

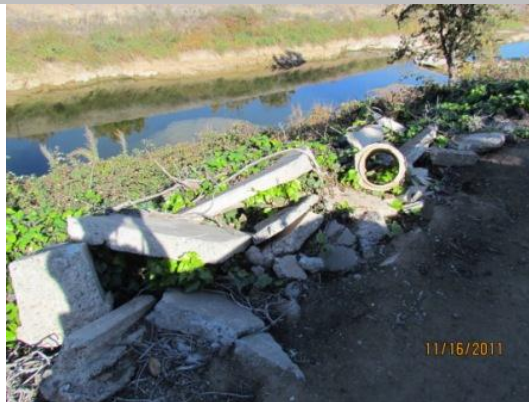
Photo 1 of 1 : pkazi_s_20140415_629.jpg

LM Start	10.87	Rating **	M	Issue No.	787
LM End	10.87	Issue Type +	En	Location *	WS
Category	Earthen Levee			GPS Latitude/Longitude	
				Start	End
Item	Encroachments				°
					°
DWR ID	DWR_NA0017_16_s_2012_787				
Action/Comments					
Debris

Concrete debris was found on the waterside of the levee looking upstream.

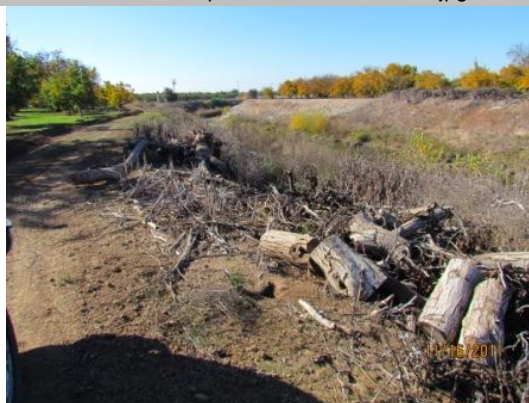
Photo 1 of 2 : pkazi_s_20140415_526.jpg

LM Start	11.07	Rating **	M	Issue No.	90
LM End	11.07	Issue Type +	Ma	Location *	WS
Category	Earthen Levee			GPS Latitude/Longitude	
				Start	End
Item	Encroachments			37.962472 °	37.962472 °
				-121.158112 °	-121.158112 °
DWR ID	DWR_NA0017_16_s_2012_90				
Action/Comments					
Prunings

Prunings were found on the waterside of the levee looking downstream.

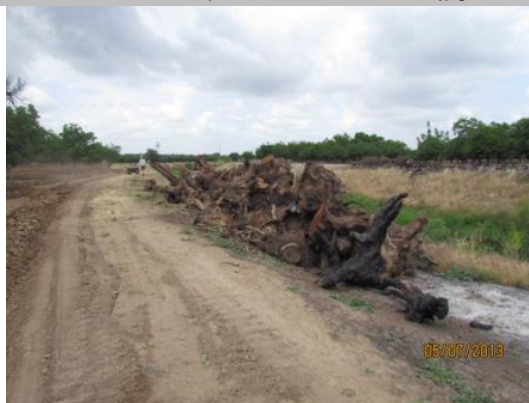
Photo 2 of 2 : pkazi_s_20140415_527.jpg

LM Start	11.07	Rating **	M	Issue No.	90 (cont)
LM End	11.07	Issue Type +	Ma	Location *	WS

Prunings were found on the waterside shoulder of the levee looking downstream.

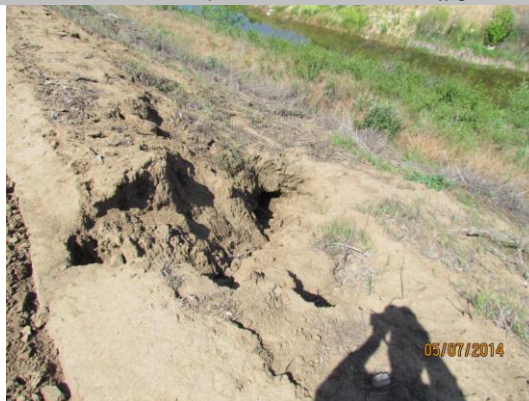
Photo 1 of 2 : pkazi_s_20140512_968.jpg

LM Start	11.11	Rating **	M	Issue No.	139
LM End	11.11	Issue Type +	Ma	Location *	WS
Category	Earthen Levee			GPS Latitude/Longitude	
				Start	End
Item	Erosion / Bank Caving			37.962182 °	37.962182 °
				-121.158684 °	-121.158684 °
DWR ID	DWR_NA0017_16_s_2013_139				
Action/Comments					
Schedule repair of erosion site prior to the next inspection.

Updated picture of the erosion on the waterside shoulder of the levee looking downstream.

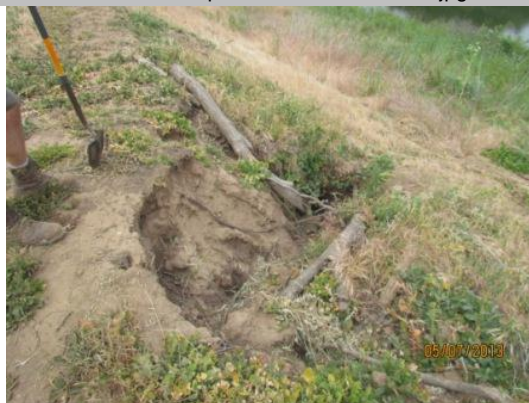
Photo 2 of 2 : pkazi_s_20140415_561.jpg

LM Start	11.11	Rating **	M	Issue No.	139 (cont)	
LM End	11.11	Issue Type +	Ma	Location *	WS	
Category	Earthen Levee			GPS Latitude/Longitude		
				Start		End
Item	Erosion / Bank Caving			37.962182	°	37.962182
				-121.158684	°	-121.158684
DWR ID	DWR_NA0017_16_s_2013_139					
Action/Comments						
Schedule repair of erosion site prior to the next inspection.

Erosion was found on the waterside of the levee looking downstream.

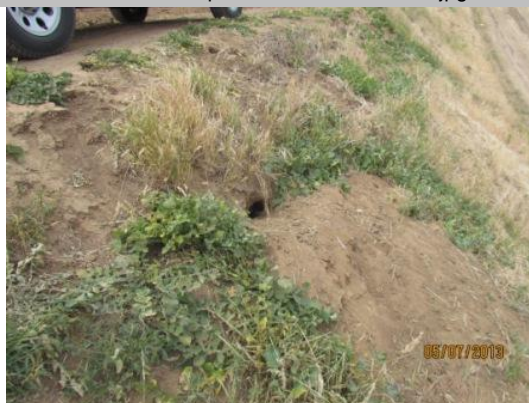
Photo 1 of 1 : pkazi_s_20140415_562.jpg

LM Start	11.16	Rating **	M	Issue No.	140
LM End	11.16	Issue Type +	Ma	Location *	WS
Category	Earthen Levee			GPS Latitude/Longitude	
				Start	End
Item	Animal Control			37.961681 °	37.961681 °
				-121.159346 °	-121.159346 °
DWR ID	DWR_NA0017_16_s_2013_140				
Action/Comments					
No rodents visible, but rodent burrows visible; need to backfill and compact or grout burrows.

An animal hole was found on the waterside slope of the levee looking downstream.

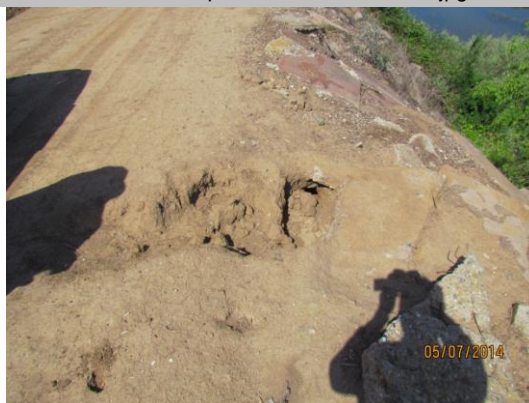
Photo 1 of 1 : pkazi_s_20140512_967.jpg

LM Start	11.21	Rating **	M	Issue No.	108
LM End	11.21	Issue Type +	Ma	Location *	WS
Category	Earthen Levee			GPS Latitude/Longitude	
				Start	End
Item	Animal Control			37.961494 °	37.961494 °
				-121.160196 °	-121.160196 °
DWR ID	DWR_NA0017_16_s_2014_108				
Action/Comments					
No rodents visible, but rodent burrows visible; need to backfill and compact or grout burrows.

Rodent holes were found on the waterside shoulder of the levee looking downstream.

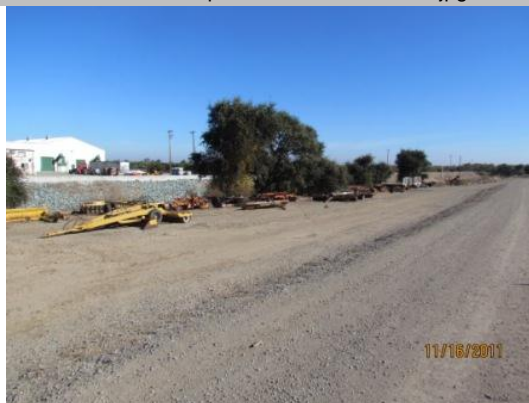
Photo 1 of 1 : pkazi_s_20140415_525.jpg

LM Start	11.52	Rating **	M	Issue No.	88
LM End	11.59	Issue Type +	En	Location *	WS
Category	Earthen Levee			GPS Latitude/Longitude	
				Start	End
Item	Encroachments			37.960282 °	37.960118 °
				-121.165380 °	-121.166580 °
DWR ID	DWR_NA0017_16_s_2012_88				
Action/Comments					
Equipment

Equipment was found on the waterside of the levee looking upstream.

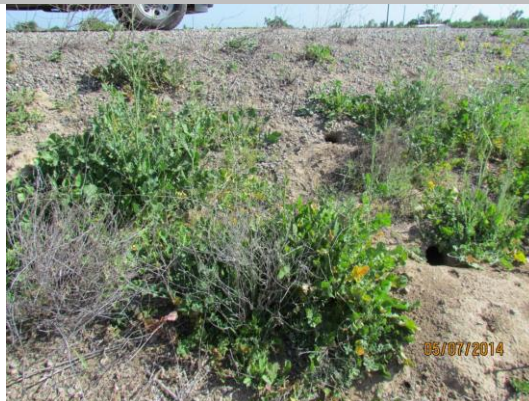
Photo 1 of 1 : pkazi_s_20140512_964.jpg

LM Start	13.41	Rating **	M	Issue No.	97
LM End	13.41	Issue Type +	Ma	Location *	LS
Category	Earthen Levee			GPS Latitude/Longitude	
				Start	End
Item	Animal Control			37.960567 °	37.960567 °
				-121.198386 °	-121.198386 °
DWR ID	DWR_NA0017_16_s_2014_97				
Action/Comments					
No rodents visible, but rodent burrows visible; need to backfill and compact or grout burrows.

A rodent hole was found on the landside of the levee looking upstream.

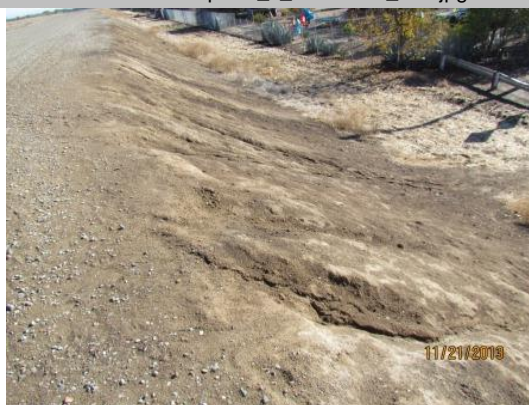
Photo 2 of 2 : pkazi_s_20140415_567.jpg

LM Start	14.58	Rating **	M	Issue No.	145 (cont)
LM End	14.58	Issue Type +	Ma	Location *	LS

Updated picture of the erosion due to runoff on the landside of the levee looking upstream.

LM Start	14.58	Rating **	M	Issue No.	145
LM End	14.58	Issue Type +	Ma	Location *	LS
Category	Earthen Levee			GPS Latitude/Longitude	
				Start	End
Item	Erosion / Bank Caving			37.966751 °	37.966751 °
				-121.216677 °	-121.216677 °
DWR ID	DWR_NA0017_16_s_2013_145				
Action/Comments					
Schedule repair of erosion site prior to the next inspection.

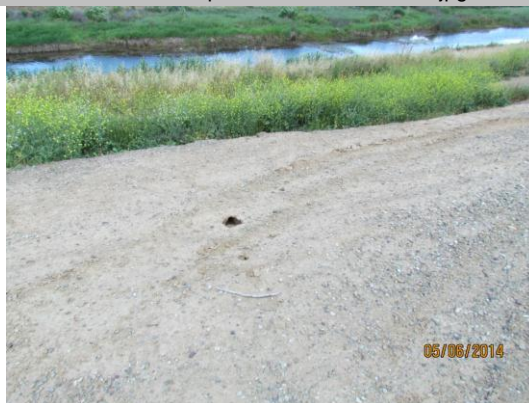
Photo 1 of 1 : pkazi_s_20140512_963.jpg

LM Start	15.52	Rating **	M	Issue No.	75
LM End	15.52	Issue Type +	Ma	Location *	CR
Category	Earthen Levee			GPS Latitude/Longitude	
				Start	End
Item	Animal Control			37.973588 °	37.973588 °
				-121.231265 °	-121.231265 °
DWR ID	DWR_NA0017_16_s_2014_75				
Action/Comments					
No rodents visible, but rodent burrows visible; need to backfill and

A rodent hole was found on the crown of the levee looking upstream.

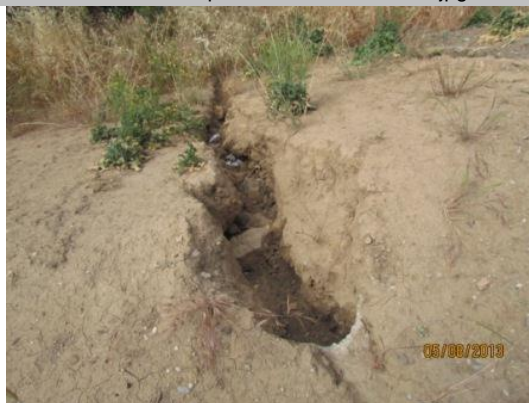
Photo 1 of 1 : pkazi_s_20140415_570.jpg

LM Start	16.83	Rating **	M	Issue No.	150
LM End	16.83	Issue Type +	Ma	Location *	LS
Category	Earthen Levee			GPS Latitude/Longitude	
				Start	End
Item	Erosion / Bank Caving			37.982318 °	37.982318 °
				-121.252095 °	-121.252095 °
DWR ID	DWR_NA0017_16_s_2013_150				
Action/Comments					
Schedule repair of erosion site prior to the next inspection.					
Inspector Comments: Runoff

Erosion was found on the landside of the levee looking downstream.
